MS Spacer

Surface Casing - Midland Basin

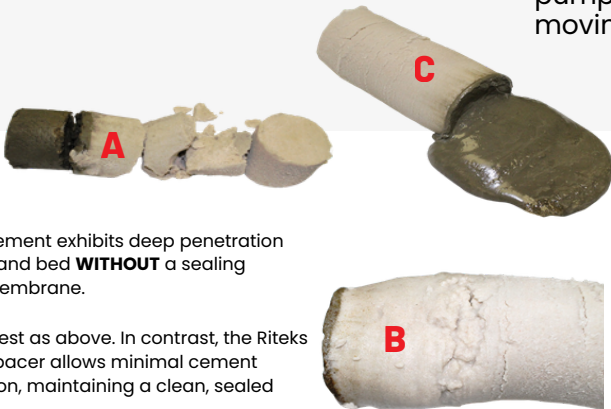
LAB SANDBED TESTS

A: Neat cement exhibits deep penetration into the sand bed **WITHOUT** a sealing spacer membrane.

B: Same test as above. In contrast, the Ritek's sealing spacer allows minimal cement penetration, maintaining a clean, sealed sand bed.

C: Birdseye view of **B**. Cement stayed in place with no leak-off, demonstrating effective sealing performance.
